Cure Evaluation of Two Critical Composite Hybrid Flat Panels for use in a High-Dimensional Stability Satellite Application

20 July 2003

R. J. ZALDIVAR and R. CASTENEDA
Space Materials Laboratory
Laboratory Operations

| 7. PERFORMING ORGANIZATION NAME(S) AND ADDRESS(ES) The Aerospace Corporation Laboratory Operations El Segundo, CA 90245-4691 | | | | 8. PERFORMING ORGANIZATION REPORT NUMBER TR-2003(8565)-6 | |

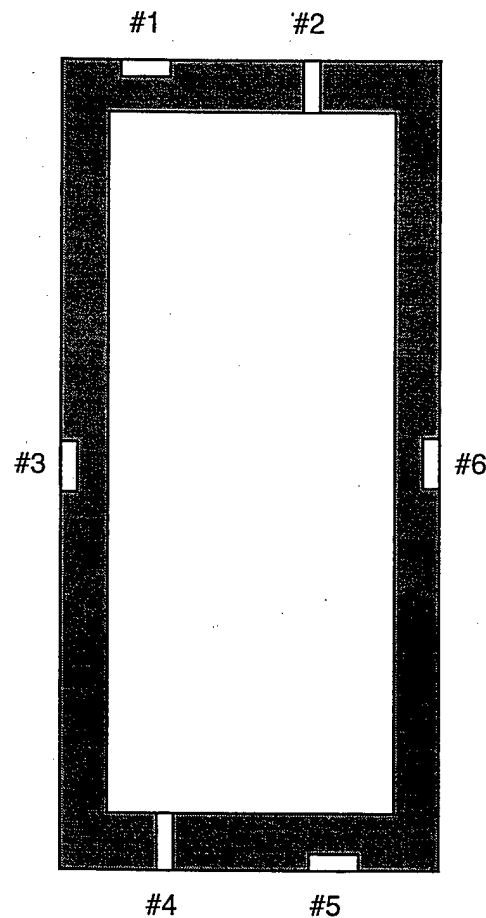
Figure 1. Schematic of composite panel tested in our investigation along with location of tag ends used for dynamic mechanical analysis testing. Gray area denotes problematic portion of laminate (window frame area) as evidenced by solvent wipe test.

The tag end samples were cut from the actual panels, as shown in Figure 1. The residue is believed to be concentrated on the outer 2 in. of the sample, similar to a window pane trace. Each of the tag end samples was tested using dynamic mechanical analysis (DMA). Each of the samples designated 1-6 was tested in two different modes. The entire thickness of the sample was tested, and only the outer few plies of specimens were also tested. Our previous studies have shown that contamination may be localized in the few outer plies, and measurements of Tg on the entire samples may be misleading unless severe degradation has occurred. Either way, if it is a surface effect or the entire sample has been affected, bonding onto this panel will make it prone to premature mechanical failure.

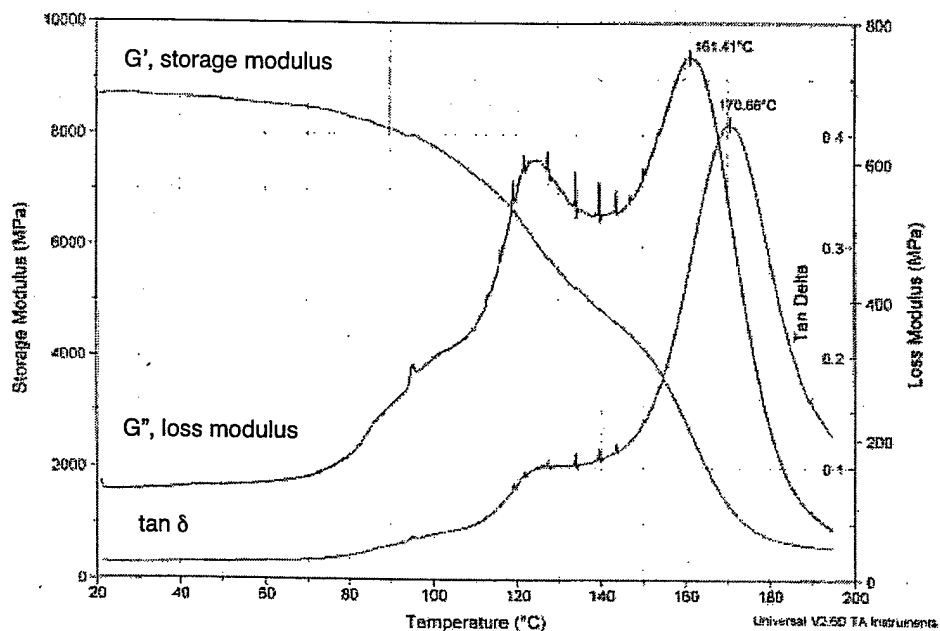
Figure 3 shows a DMA scan for panel 1. This scan shows the loss modulus as a function of temperature. Typically, the peak value for the loss modulus indicates the T_g. This material should produce a single loss modulus peak centered at about 170–175°C. As shown, the loss curve appears to be a combination of a number of peaks. This is usually an indication of severe hydrolysis contamination. As shown, there is a shoulder at 100, a peak at 125, and one at 165°C. This scan describes a resin system that is not only undercured but has regions cured to varying degrees. In other words, portions of the network have cured significantly while others are only slightly branched. Upon heat-treatment exposure, the lower crosslinked areas of the polymer are easily softened and cannot resist thermal degradation. Not only is this polymer system only partially cured, the hydrolysis of the system creates a more linear, less compliant matrix material that is different in chemical structure than what was intended. This DMA scan indicates serious moisture contamination. Additional heat treatments would have no effect on advancing the resin further or improving crosslinking density. Samples from this panel were placed in a solvent bath for a specific length of time as described in a previous publication.² The system was observed to completely dissolve within 5 min. Well-cured systems will not dissolve, even after exposure up to 5 h.

Figure 3. Typical DMA scan of Panel 1 on the outside edges.

Table 1 shows a compiled list describing the measured Tg values for the many tag end samples from Panel 1. As shown and described previously, there are a number of multiple Tg values for each tag end. This indicates severe moisture contamination. Samples 2 and 4 represent areas of the panel 0.05, 1.0, and 2.0 in. from the outer edge. The Tg values increase as the samples move in a few inches from the outer edges. However, even at a 2.0-in. depth, the resin still appears compromised. A Tg value of 165°C for this resin has been shown in previous publications to be both mechanically and thermally affected. Tag-end samples 3, 5, and 6 indicate changes in Tg values from the edge of the sample to 1.0 in. from the edge into the panel. Again, the values indicate an increase in Tg, showing improvement, but significantly lower than a well-cured material. The samples (1, 3, 5, and 6) tested laterally around the perimeter of panel 1 were shown to be quite consistent. The entire panel appeared to be hydrolyzed to the same degree on the outer sections. The Tg data for this panel shows that this composite was severely affected during cure. Mechanical flatwise tension tests are currently being performed, and the contractor has stated that preliminary data shows a higher-than-expected degree of scatter and low strengths. Once the resin becomes hydrolyzed during cure there is no remedy to obtain full cure. The by-products created during hydrolysis prevent a well-crosslinked, fully cured end product. Multiple peaks in the Tg curves for most tag ends led us to recommend scrapping the panel. Other issues, such as severe microcracking, thermal expansion coefficients, moisture absorption and thermal capabilities, will be affected.

- We do not recommend using Panel 1 due to the severe degree of contamination that has occurred to the composite. Bonding to the surface of the composite may greatly affect mechanical performance. However, Panel 2 appears to be fairly well cured, especially 1.0 in. in from the outer perimeter. Panel 2 appears satisfactory for use with respect to its degree of cure. Additional, flatwise tension tests should be performed to evaluate variability and strength.

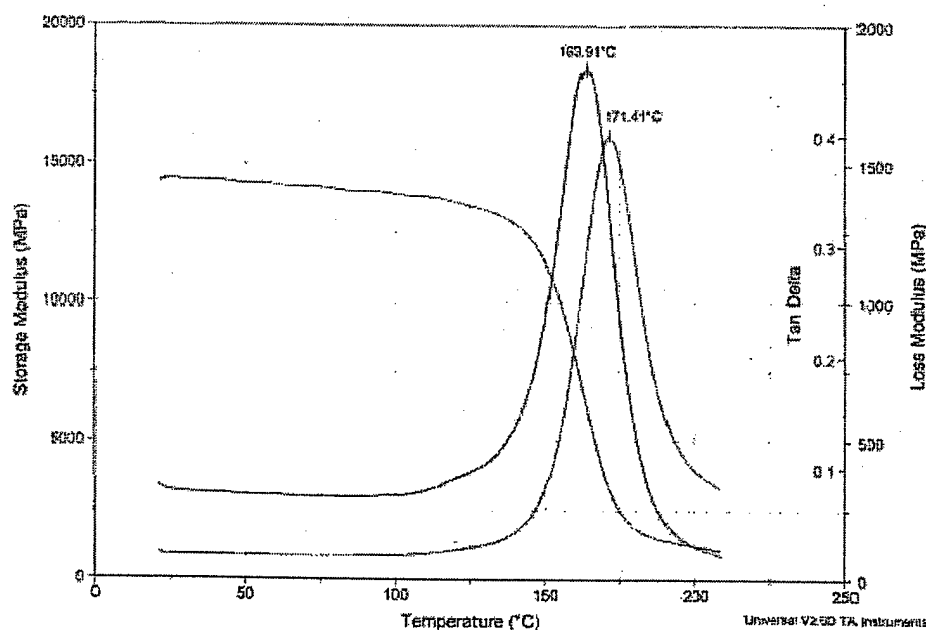
Table 2 shows a compiled list describing the Tg values for the tag end samples from Panel 2. As shown and in contrast to panel 1, all of the samples for panel 2 had only one single sharp peak for the loss modulus. The DMA scan shown in Figure 3 shows this loss modulus peak, which represents the glass-transition temperature of the material. Samples 2 and 4 represent areas of the panel moving in from the outer edge. As shown, the Tg values show a slight increase in Tg as we move into the bulk of the panel. The slightly lower Tg on the outer perimeter may be due to some hydrolysis of the polymer. However, the Tg values are all quite high and above the values that

Figure 4. Typical DMA scan of Panel 2 on the outside edges.

are indicative of a well-cured system. The other Tg values taken from the tag ends around the perimeter of the panel indicate minimal changes and that full cure has occurred. The overall cure state of Panel 2 appears to be sound. It is quite surprising that the state of Panel 1 is so degraded in comparison to Panel 2 since both panels were processed simultaneously.

At this time, we don't know whether both panels were fabricated using the same lots of material. Flatwise tension tests should still be performed to ensure that good consolidation of the panel has occurred; however, the cure state is satisfactory, and we see no reason to discard Panel 2. To assure highest reliability, Panel 2 should be machined 1.0 in. from the outer perimeter to remove any contaminated material.

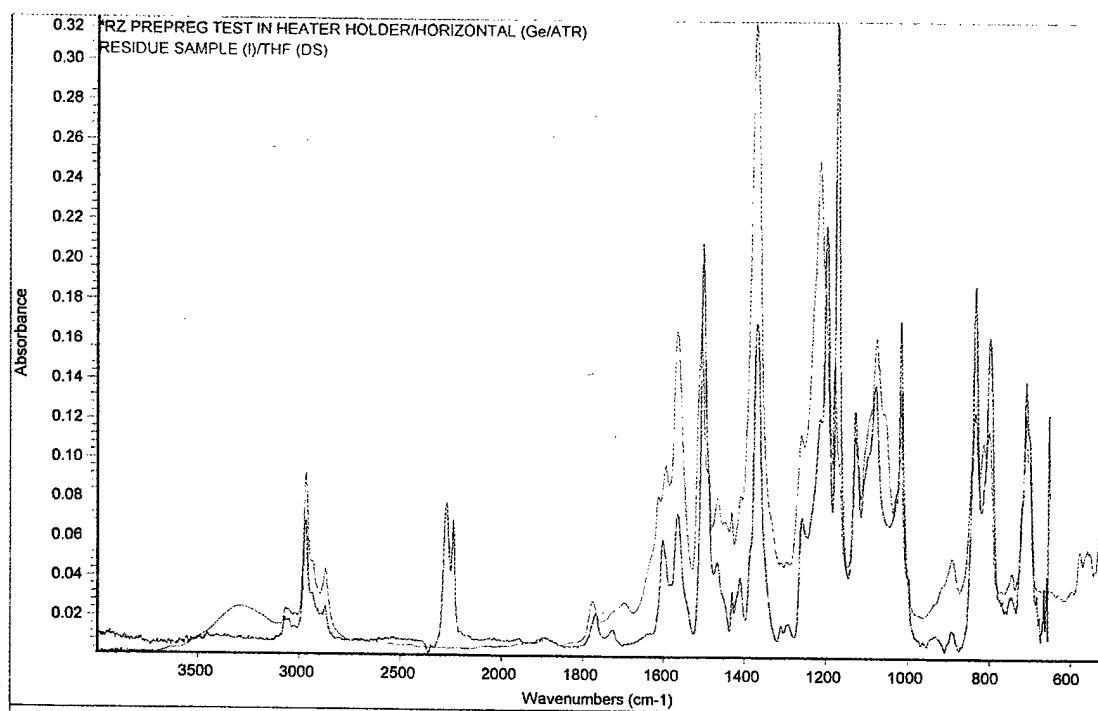
The third peak to focus on is located at approximately 1750 cm^{-1} . This is a carbonyl peak that is usually indicative of hydrolysis of the cyanate ester occurring during the polymerization process. This type of carbamate contamination is the primary cause for large variations or decreases in the glass-transition temperature of the resin, even after heat treatment to high temperature. Figure 7 shows a typical FTIR with limited contamination.

Figure 7. FTIR spectra showing indications of limited moisture contamination during cure. Blue spectra shows uncured system to emphasize differences in spectra.
